UNITED STATES V. SHELL CHEMICAL LP

FENCELINE MONITORING - CORRECTIVE ACTION PLAN

SHELL NORCO MANUFACTURING COMPLEX CORRECTIVE ACTION PLAN

Benzene Fenceline Monitoring 40 CFR 63 Subpart CC Reporting Period: October 21, 2021 through November 4, 2021

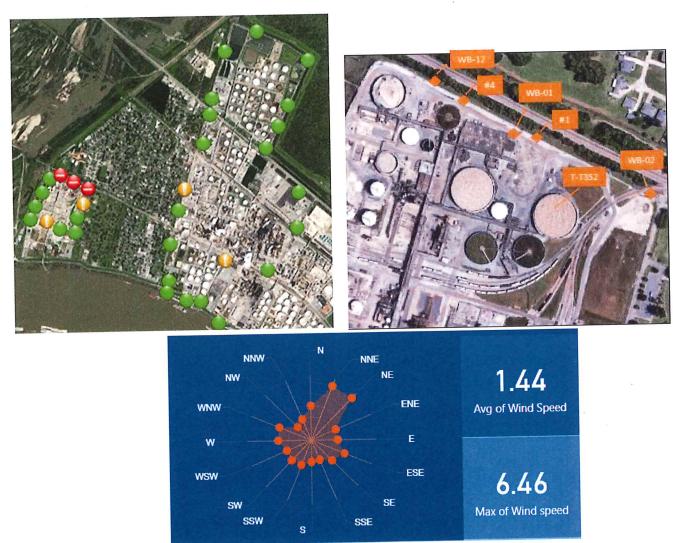
Figures IV-1, IV-2, and IV-3: Map of Monitoring Results and Wind Rose for 10/21/21-11/4/21

During the sample period from October 21, 2021 through November 4, 2021, the period Δc was above the action level, and the annual rolling Δc with the inclusion of this period exceeded the action level. A wind rose and map of the monitoring locations is provided below wherein the red points show the monitors above the action level.

Table IV-1: Data for 10/21/21 − 11/4/21 ΔC	Benzene (μg/m³)
Period ΔC	29.44
Refinery Annual Rolling △C	13.98
Chemical Annual Rolling △C	13.28
Sample point(s) higher than action level:	Benzene (μg/m³)
WB-01	19.00
WB-02	30.00
WB-12	13.00

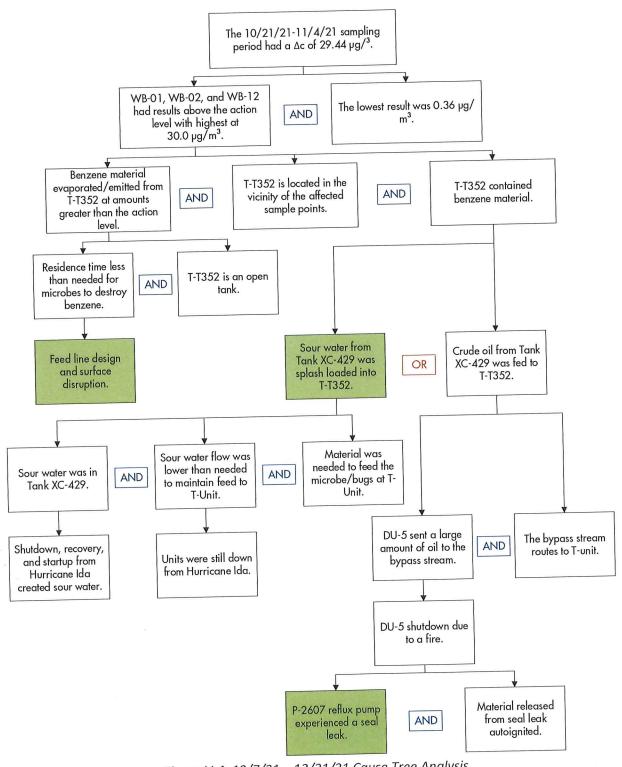
Figure V-4: 12/7/21 – 12/21/21 Cause Tree Analysis

Due to Hurricane Ida (August 29, 2021), the sour water tank XC-429 was stagnant until power was re-established after the storm. Once power was restored at XC-429, water from this tank needed to be transferred to the biotreater (T-Unit) to get feed to the (microbes that break down sour or hydrocarbon material- without feed for prolonged periods, the microbes could die). Since units were not fully up and running at this time due to the hurricane, sour water feed to T-Unit was lower than that needed to have continuous feed. To get the sour water from XC-429 to the bio-treater to feed the bugs, sour water was batched into the bio-treater T-T352 via splash loading. One of these batch transfers started on October 26 at 2:00 PM. The dissolved oxygen of the system started to drop significantly during this transfer which indicated hydrocarbons being sent to the system.

On October 31, 2021, after the drop in dissolved oxygen on October 26 and 27, 2021, sour water feed from XC-429 was stopped, and the bypass stream's sour water tank XC-7005 was surged. Transfers from XC-429 to T-Unit were resumed on October 29th. These transfers were started at a low rate and were slowly increased during the following days.

On November 1, 2021, the refinery distillation unit (DU-5) was in the process of the unplanned startup post Hurricane Ida and experienced a fire. DU-5 lost instrumentation on desalters and had to shut down some equipment, which caused the unit to send a large amount of oil to the bypass stream. A sample coming into T-unit of dark feed was received at 8:49 PM. It was determined that the sample was mainly crude. Following the investigation, the fire was found to be caused by a pump seal leak from P-2607.

The Cause Tree below in Figure V-4 depicts the root cause(s) identified for this period. The green boxes represent a root cause that was directly addressed with a corrective action identified in Table V-2. Note that not every cause must be addressed to break the tree and prevent recurrence. Specific causes were chosen to address with actions as marked in the green boxes on the tree.

Pump was taken out of service and repaired. Seals were converted to dual seals.	1/15/22	This post-event corrective action was taken to reduce probability of a pump seal leak in the future as the pump seal caused the fire.

Corrective Actions	Completion Date	Comments
Entire Period		
The feed lines to T-T352 were lowered to increase residence time and decrease surface disruption.	11/23/21	This post-event corrective action was taken to reduce benzene emissions around the #1 and #4 eGC and the fenceline monitors (WB-01, WB-02 and WB-12) in the future.

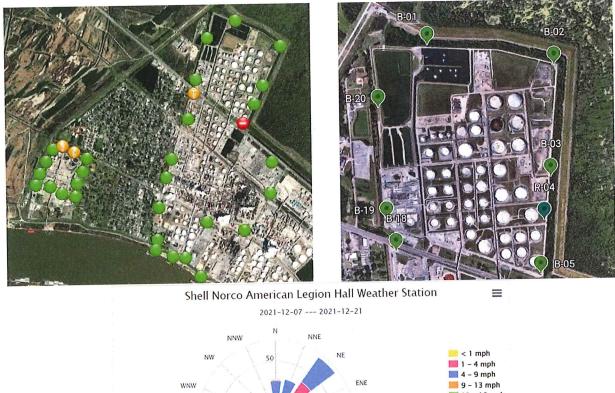
Figures V-1, V-2, and V-3: Map of Monitoring Results and Wind Rose for 12/7/21 – 12/21/21

During the sample period from December 7, 2021 through December 21, 2021, the period Δc was above the action level, and the annual rolling Δc with the inclusion of this period exceeded the action level. A wind rose and map of the monitoring locations is provided below wherein the red points show the monitors above the action level.

Table V-1: Data for 12/7/21 − 12/21/21 ΔC	Benzene (µg/m³)
Period ΔC	15.50
Refinery Annual Rolling △C	13.71
Chemical Annual Rolling △C	13.50
Sample point(s) higher than action level:	Benzene (μg/m³)
B-05	16.00

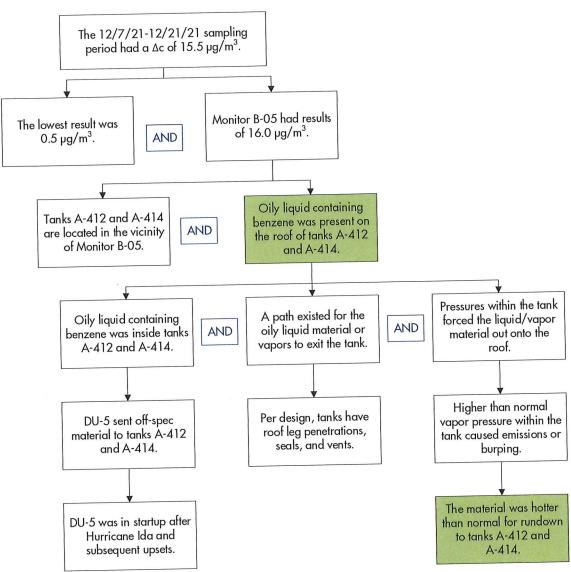
Figure V-4: 12/7/21 – 12/21/21 Cause Tree Analysis

On December 15, 2021, during the refinery distillation unit (DU-5) startup, off-spec rundown was sent to tanks A-412 and A-414. This rundown material was at temperatures higher than normal causing vapors and material to be released from the legs and seal on tanks A-412 and A-414.

On December 20, 2021, an investigation began into the source of an odor identified near the North Property Tank Farm. Liquid was found on the roof of tanks A-412 and A-414.

The Cause Tree in Figure V-4 depicts the root cause(s) identified for this period. The green boxes represent a root cause that was directly addressed with a corrective action identified in Table V-2. Note that not every cause must be addressed to break the tree and prevent recurrence. Specific causes were chosen to address with actions as marked in the green boxes on the tree.

Table V-2: Corrective Actions for 12/7/21 Corrective Actions	Completion Date	Comments
Identify any and all activities which took place in the affected area during this time.	1/8/22	No known work activities took place during the 2-week sample period in the affected area. There was a community complaint during this time, so operations began investigating the source of the odor (12/20/21).
Identify any process abnormalities as potential contributing factors to the elevated readings on the eGC and the fenceline monitor (B-05).	1/8/22	Noted the process abnormality of the rundown material being at a temperature higher than normal (abnormality identified 12/15/21)
Tank operators noticed high temperatures, and DU-5 was notified of the high temperatures and requested that the unit	12/15/21	During DU-5 start-up, off-spec rundown was being received into Tanks A-412 and A-414. The off-spec rundown was at a temperature higher than normal.

Corrective Actions	Completion Date	Comments
lower temperatures of the feed into the tanks.		
Utilize handheld monitoring devices for visual field observations.	12/15/21 and 12/20/2021	Handheld devices did not show elevated readings along Airline Hwy with an MX6.
Oil removed from roofs of the Tanks A-412 and A-414.	12/21/21	Tanks at the south end of North Property were found to be the contributing sources. The oil was removed from the roofs of both tanks.

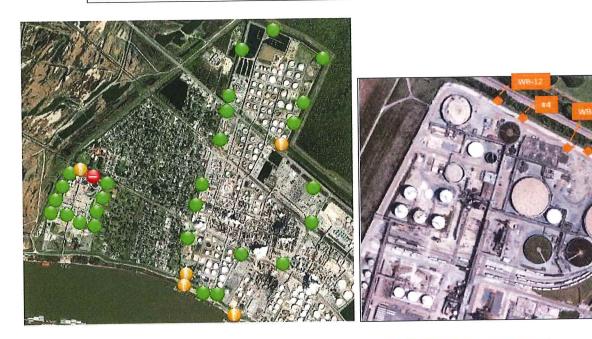
Figures VI-1, VI-2, and VI-3: Map of Monitoring Results and Wind Rose for 12/21/21 - 1/5/22

During the sample period from December 21, 2021 through January 5, 2022, the period Δc was above the action level, and the annual rolling Δc with the inclusion of this period exceeded the action level. A wind rose and map of the monitoring locations is provided below wherein the red points show the monitors above the action level.

$\Delta \mathbf{C}$	Benzene (µg/m³)
Period ΔC	13.51
Refinery Annual Rolling ΔC	13.88
Chemical Annual Rolling ΔC	13.87
Sample point(s) higher than action level:	Benzene (µg/m³)
WB-01	14.00

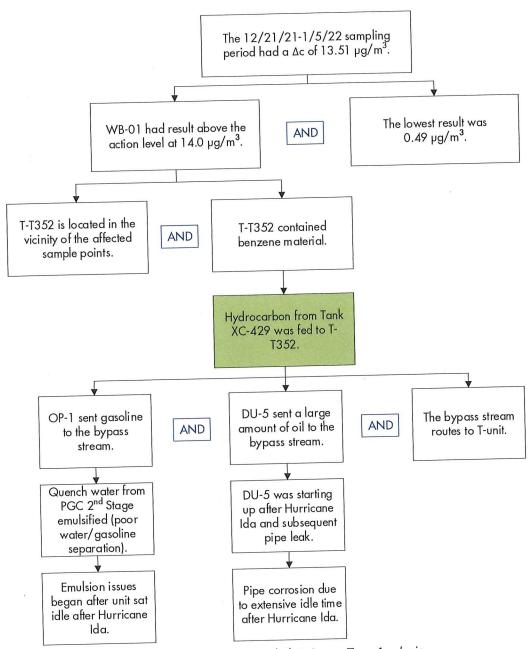
Figure VI-4: 12/21/21 – 1/5/22 Cause Tree Analysis

Between December 19 – December 28, 2021, elevated benzene results were detected in the sour water from the DU-5 Unit. During this time, DU-5 was in the process of restarting the unit following an extended shutdown after Hurricane Ida resulting in crude oil getting into the sour water bypass system. Notably, a fire as well as a pipe leak due to corrosion both elongated the start-up process of DU-5.

Elevated benzene sample results from one of the chemical manufacturing units, Olefins Production Unit 1 (OP-1), were received between December 31, 2021 and January 4, 2022 which is presumed to be the source of the high results from the eGC monitoring during that period. Since the restart after Hurricane Ida, the OP-1 quench water from the process gas compressor (PGC) 2nd stage stream has been emulsified resulting in poor water and gasoline separation causing elevated benzene carryover to the sour water system.

The Cause Tree in Figure VI-4 depicts the root cause(s) identified for this period. The green boxes represent a root cause that was directly addressed with a corrective action identified in Table VI-2. Note that not every cause must be addressed to break the tree and prevent recurrence. Specific causes were chosen to address with actions as marked in the green boxes on the tree.

Corrective Actions	Completion	Comments	
	Date		
dentify any and all activities which took	1/20/22	The routine transfer of sour water from Tank XC-429 to	
place in the affected area during this time.		the T-Unit bio-treater was occurring during this time.	
dentify any process abnormalities as	1/20/22	Routine sour water sample data indicated process	
potential contributing factors to the		upsets in the DU-5 and OP-1 Units during this time	
elevated readings on the #1 and #4 eGC and		period. No additional process abnormalities were	
the fenceline monitors (WB-01, WB-02, and		identified.	
WB-12).

Corrective Actions	Completion Date	Comments
the level of XC-7005 was raised to skim oil,	1/3/22	emissions around the #1 and #4 eGC and the fenceline
and the level in XC-429 was raised to make		monitors (WB-01, WB-02, and WB-12).
sure there was enough space to surge and		
allow tank materials to separate.		2
